WALLKILL RIVER BASIN
SAWMILL BROOK, SUSSEX COUNTY
NEW JERSEY

HEATERS POND DAM NJ 00795

PHASE 1 INSPECTION REPORT
NATIONAL DAM SAFETY PROGRAM

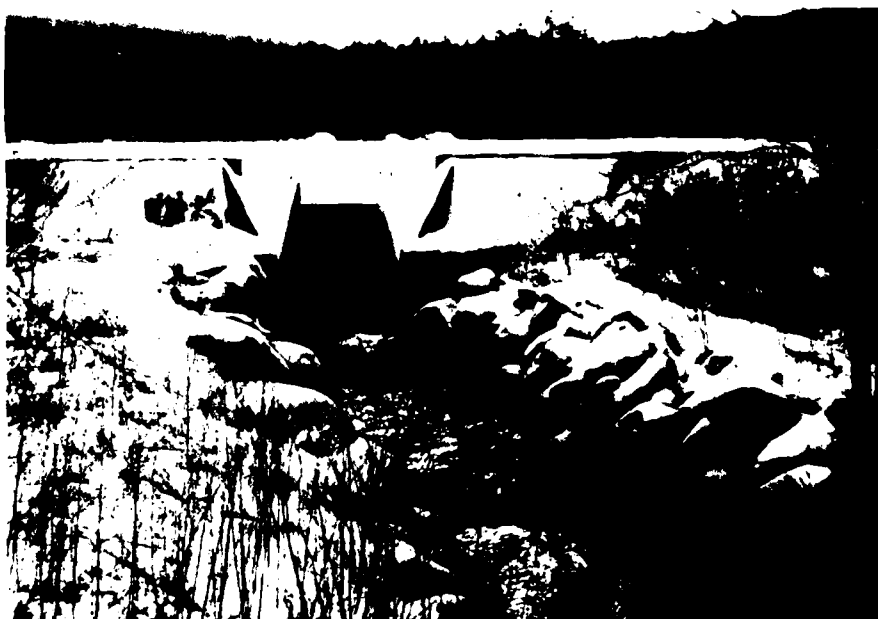
PHOTO 1

DOWNSTREAM SIDE OF SPILLWAY SHOWING RIPRAP ALONG DOWNSTREAM CHANNEL

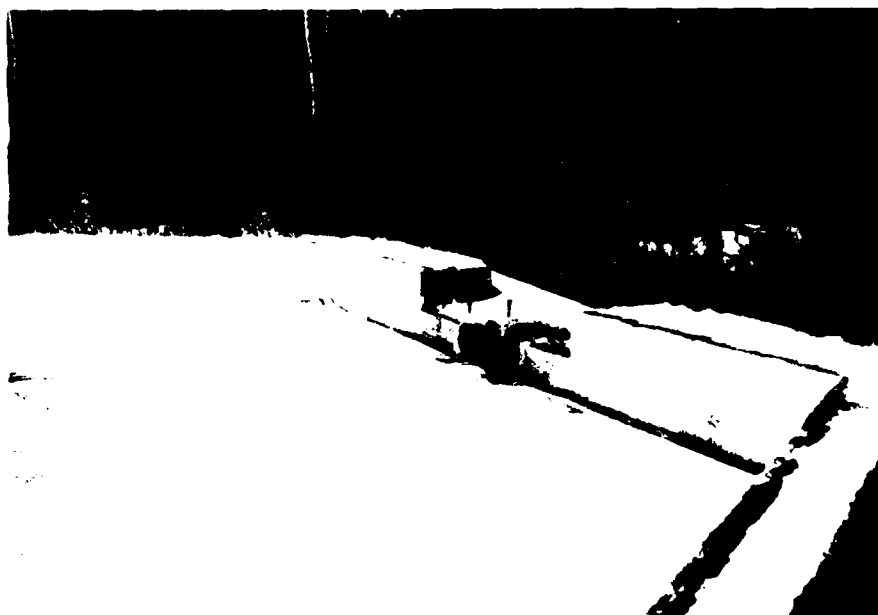
PHOTO 2

UPSTREAM SIDE OF SPILLWAY

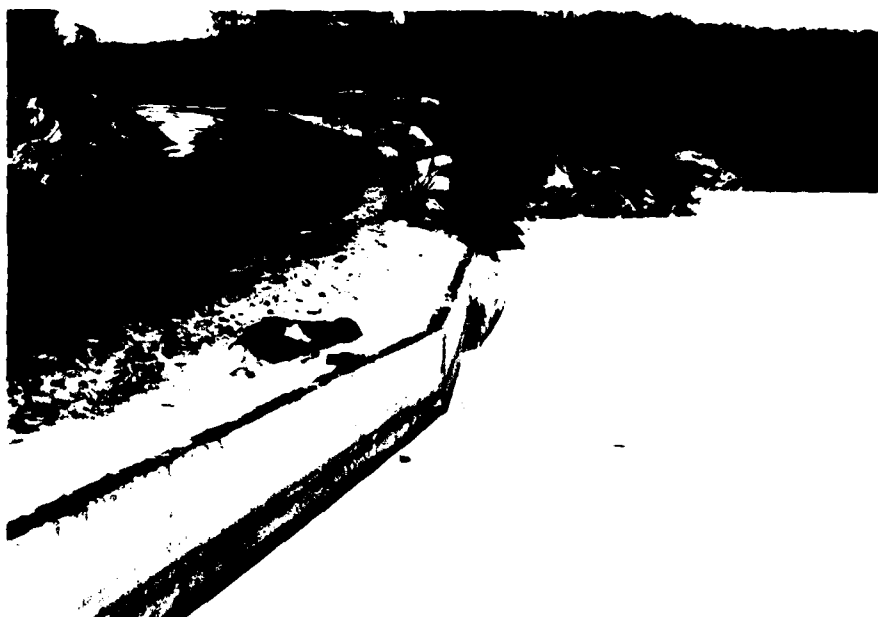
PHOTO 4

The concrete wall located to the right of the spillway was in satisfactory condition. The crest of the left embankment was generally level and grass covered with some small trees on the upstream and downstream faces. A swampy area containing standing water was located at the downstream toe of the embankment near its left end. Portions of the standing water were not ice covered whereas the lake was frozen. In addition, an area of standing water was observed at the toe of embankment adjacent to the left side of the downstream channel.

CONCRETE WALL ALONG LAKE SHORE - RIGHT OF SPILLWAY

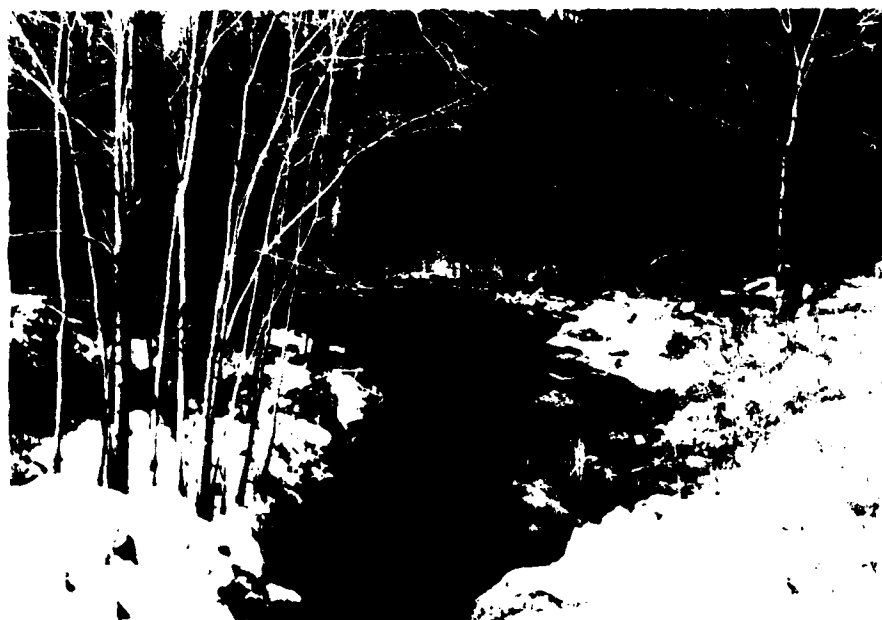
PHOTO 8

VISUAL EXAMINATION OF	OBSERVATIONS	REMARKS OR RECOMMENDATIONS
CONDITION (OBSTRUCTION, DEBRIS, ETC.)	In immediate vicinity of spillway channel was well graded and lined on bottom and both banks with limestone riprap. Stone size and placement appeared adequate. Channel then extends down side of mountain with narrow rocky flood plain resembling gorge.	
SLOPES	Side slopes rocky, wooded and very high - resembling gorge.	
STRUCTURES ALONG BANKS	Dwelling adjacent to channel about 800' downstream. Railroad bridge located about 1500' downstream. Road bridge (Rt. 517) about 3600' from dam. Several dwellings adjacent to channel 3600' to 7200' downstream from dam.

DOWNSTREAM CHANNEL IN VICINITY OF DAM
